Visual inspection for Control Rod Drive Mechanism (CRDM) canopy seals

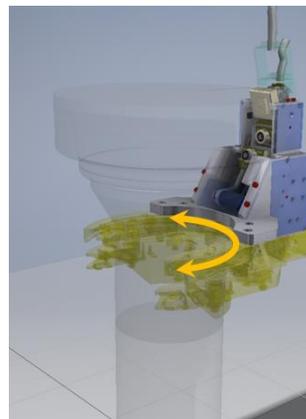
Figure 1 – Clamp and its inspection device docked on a penetration

The visual inspection device includes two cameras and lighting blocks and is installed on a clamp that is docked to the CRDM penetration. The clamp and thus the visual inspection device can rotate around the penetration in order to perform a 360° visual inspection of the canopy weld (Figure 1). The two cameras on the visual inspection device are mobile in three axes to obtain the best view angle of the canopy weld.

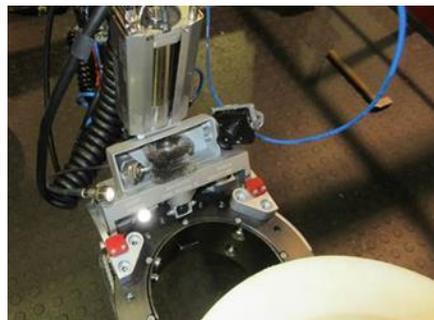
Figure 2 – Brushing tool

A brushing tool, installed on the clamp (Figure 2), is also available to brush any obstructions or deposit which could prevent a complete visual inspection of the weld.

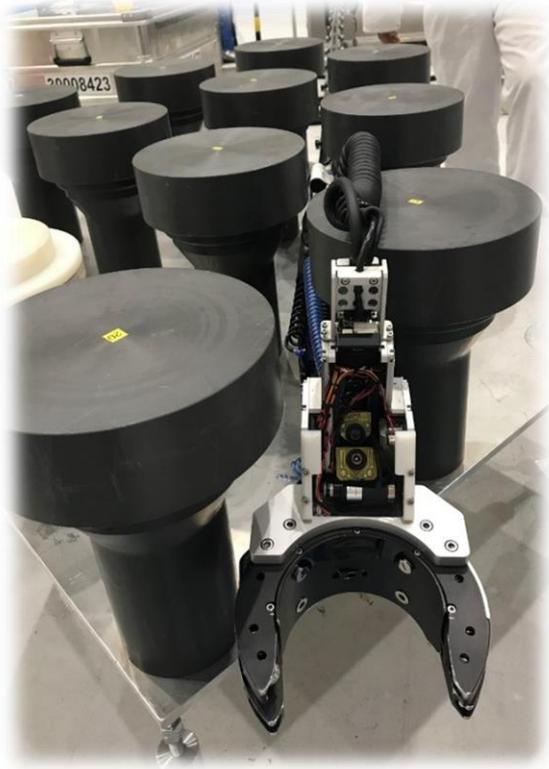
Figure 3 – Clamp and its inspection device going through penetration mockups

The tool carrier, designed to bring the clamp and its visual inspection device to the CRDM penetration, navigates through the tight space between the penetrations (Figure 3). The tool carrier is clamped on the side of the RVH (Figure 4).

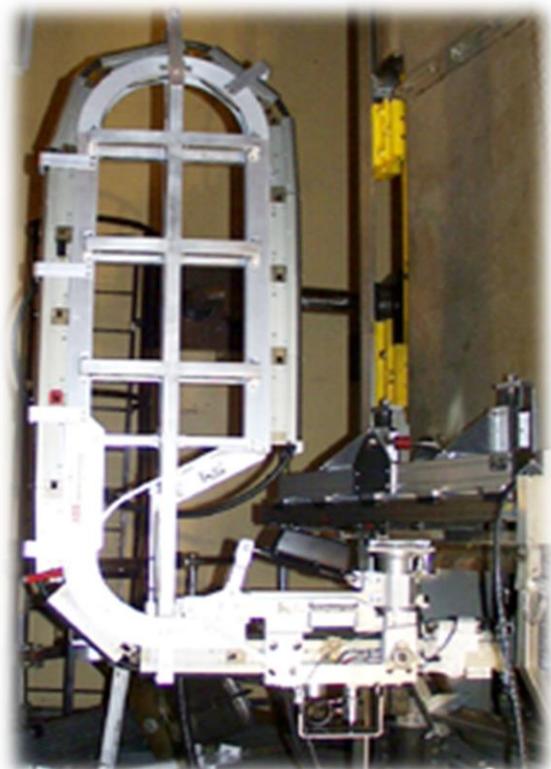
Figure 4 – Tool carrier outside of the RVH
